DEPARTMENT OF TRANSPORTATION

Contract #: 04-0120F4Cty: SF/ALA Rte: 80 PM: 13.2/13.9File #: 69.28**WELDING INSPECTION REPORT****Resident Engineer:** Pursell, Gary**Address:** 333 Burma Road**City:** Oakland, CA 94607**Report No:** WIR-014603**Date Inspected:** 27-May-2010**Project Name:** SAS Superstructure**OSM Arrival Time:** 700**Prime Contractor:** American Bridge/Fluor Enterprises, a JV**OSM Departure Time:** 1900**Contractor:** Zhenhua Port Machinery Company, Ltd (ZPMC), Changxing Island **Location:** Shanghai, China

Bridge No: 34-0006**Component:** Tower Components**Summary of Items Observed:**

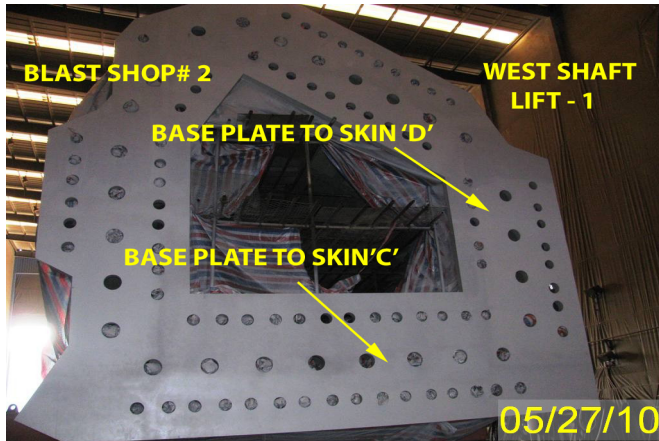
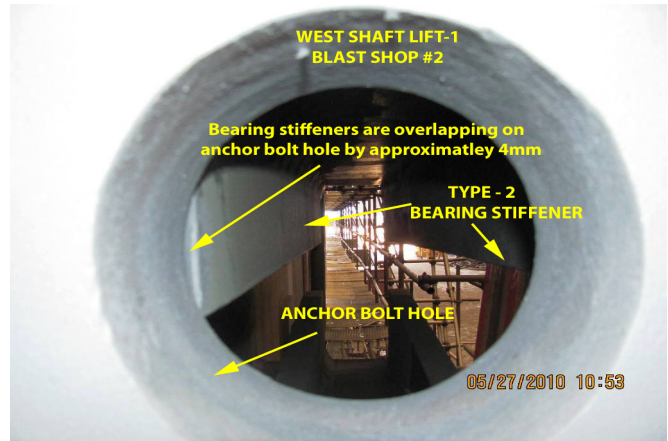
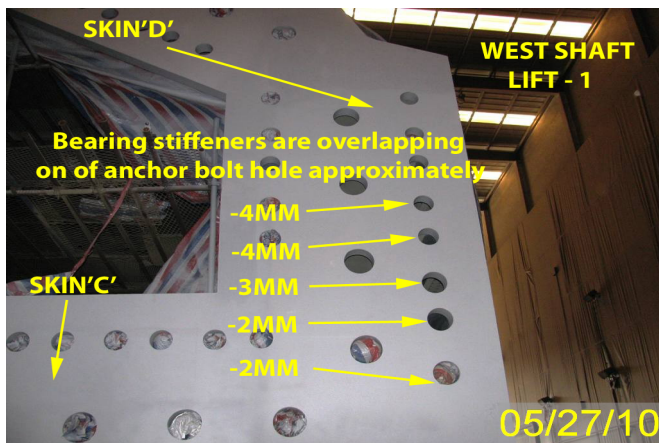
During the Quality Assurance Inspection of Anchor Bolt Hole to Bearing stiffener distance measurement at West shaft Skin D External side, this Quality Assurance Inspector (QA) discovered the following issue:

- Type 2 Bearing stiffeners are overlapping on top of anchor bolt hole.
- Type 2 Bearing stiffeners to Anchor bolt hole distances at five (5) different locations found approximately -2 mm, -2mm, -3mm, -4mm, -4mm.
- The Anchor bolt holes found inappropriate readings are consecutive from Skin 'C' side. (For readings see above)
- These bearing stiffeners are found in Skin C of External West Shaft Lift 1.
- The location is Skin D, near CD Corner.

RFI 2024 – “To facilitate fabrication and to avoid rework, the distorted (interior) bearing stiffener PL #2 's in Lift 1 East Shaft are acceptable as fit-for-purpose, provided that all of the following conditions are met:”

“1. Bearing stiffener PL #2 shall not conflict with the anchor bolt holes in the base plate...”
